Contract #: 04-0120F4Cty: SF/ALA Rte: 80 PM: 13.2/13.9File #: 01.28**WELDING INSPECTION REPORT****Resident Engineer:** Casey, William**Address:** 333 Burma Road**City:** Oakland, CA 94607**Report No:** WIR-029948**Date Inspected:** 23-Aug-2013**Project Name:** SAS Superstructure**OSM Arrival Time:** 700**Prime Contractor:** American Bridge/Fluor Enterprises, a JV**OSM Departure Time:** 1730**Contractor:** American Bridge/Fluor Enterprises, a JV**Location:** Job Site

ESW S-043, Location "T" Face B

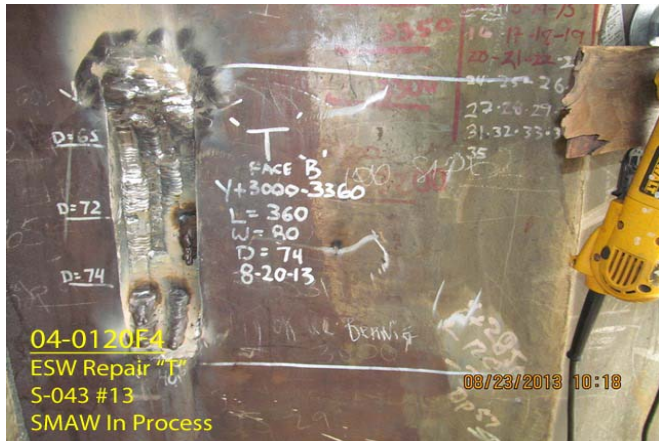
The QAI periodically observed ABF welding personnel Mike Jimenez utilizing the Shielded Metal Arc Welding (SMAW) process in the vertical (3G) position with Atom Arc E7018-1 H4R, 5/32" diameter electrode to continue welding excavation for weld repair. The welding is taking place on the exterior (west) side at joint T, weld #S-043 on Face B side for a repair designated as 201308-004. Excavation dimensions are noted as Y=3000mm-3360mm, Length=360mm, Width=80mm, Depth=74mm. The QAI observed the interpass temperature was maintained at approximately 360 degrees Fahrenheit with electric heating coil blankets through a heat induction system and a rose bud torch. The QAI verified interpass temperature with a thermal heat gun. As welding continued the QAI periodically verified welding parameters at approximately 140 amperes per ABF-WPS-D1.5-ESW-80-100TR. The welder was also observed using proper interpass cleaning methods with a slag hammer and a wire brush. QC Inspector Jesus Cayabyab was monitoring the progress of this repair on this date.
